Vehicle: 2020 Dodge Ram 1500

Report Date: October 30, 2025

## • Test Result **BELOW AVERAGE**

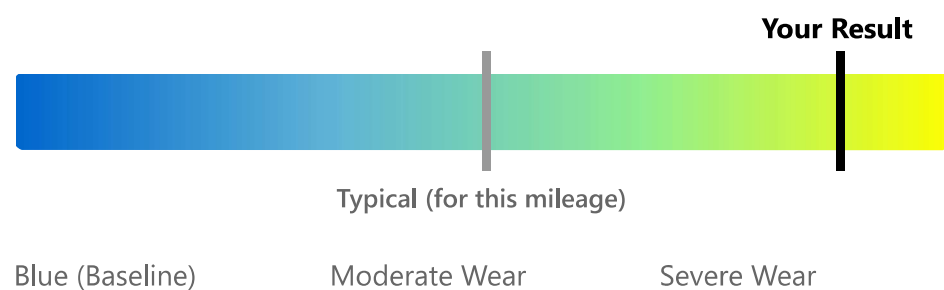
Submitted Vial Sample:

### Observed Color: Yellow-Green

The sample shows a yellow-green tint, which indicates elevated internal contamination and higher-than-typical combustion-gas bypass for this mileage.

- **Follow manufacturer service intervals.** Keep up with oil and filter changes using the recommended oil grade and interval.
- **Inspect ventilation components.** Check the crankcase ventilation system (PCV) for blockages or faults.
- **Monitor oil condition and level.** Look for unusual color, smell, or rapid consumption and address promptly.
- **Consider a compression/leak-down check.** If contamination persists, a mechanical inspection helps identify ring or cylinder wear.
- **Retest in 6–12 months.** A follow-up test will show if contamination is stable or increasing.

**Recommended Retest: 6–12 months**

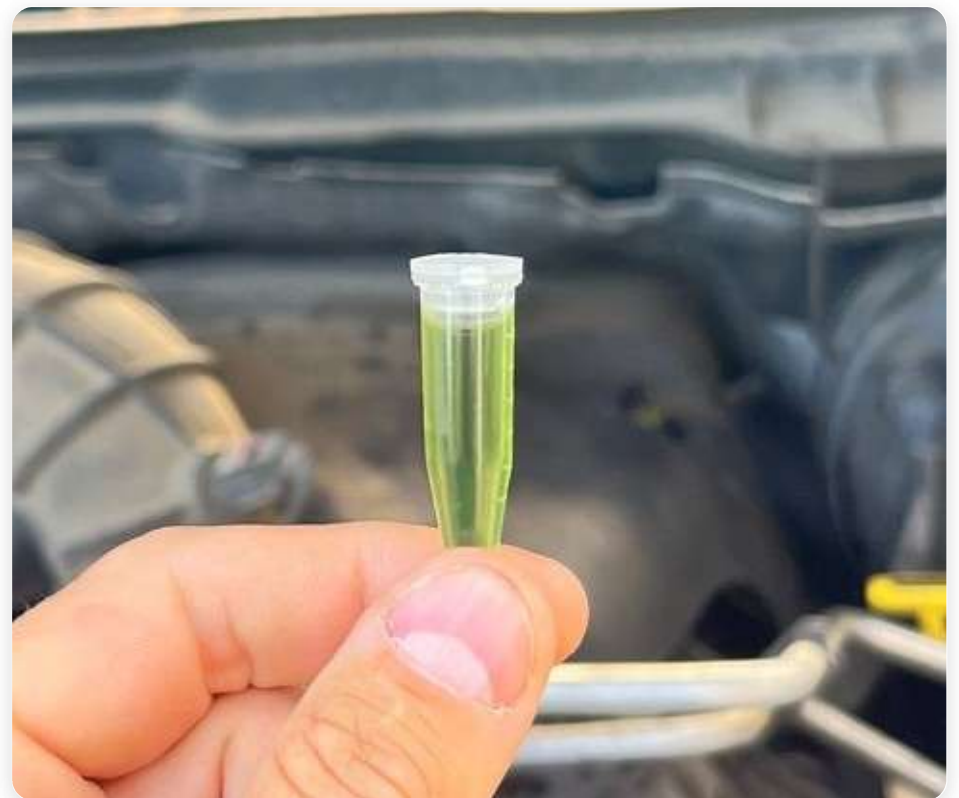
Your submitted test sample

**Estimated Wear Index: 62 / 100 (Below Average)**

Based on the observed color and the vehicle mileage, the estimated wear index is **62/100**. This reflects more internal contamination compared to typical examples of the same model and mileage range.
